# "OOPS, IT DIDN'T ARM." - A CASE STUDY OF TWO AUTOMATION SURPRISES

Everett Palmer, NASA - Ames Research Center

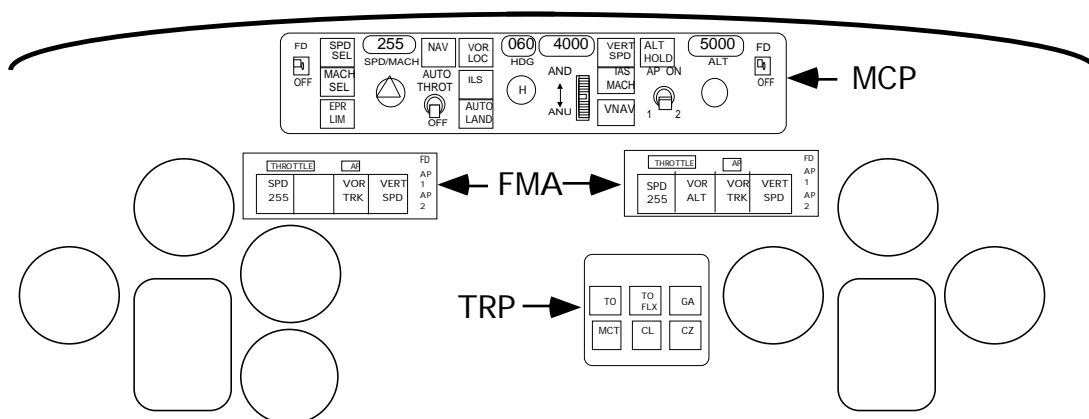
This paper will examine in detail the automation surprises that occurred on two simulated glass cockpit flights that were part of a line oriented simulator study of cockpit automation (Wiener, et al, 1991). These incident descriptions were reconstructed from data from two cockpit video cameras. One camera provided a wide angle view of the cockpit and the other provided a close up view of the altimeter and the Flight Mode Annunciator (FMA) display (see Fig. 1).

Figure 1. Autoflight Controls and Displays: A Mode Control Panel (MCP), two Flight Mode Annunciators (FMA) and a Thrust Reference Panel (TRP).
